Automated gates

This safety alert highlights serious health and safety risks posed by automated gates. It applies to gates not fitted with safety devices to guard against injury as the gate opens and closes, and follows a serious incident in which a child was injured.

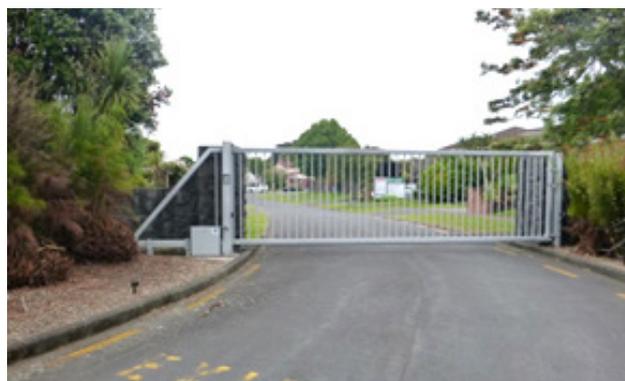
FIGURE 1: The gate when closed

- signage warning people to keep clear of gates when they are activated
- buzzer/beeper/flashing beacon devices to warn of impending gate movement
- pressure sensor for gate's leading edge
- motor/gearbox torque-limiting to limit the moving gate's force plus momentary automatic reversal mechanism to release entrapped objects
- an accessible clearly labelled emergency stop button, programmed with momentary reverse
- accessible clearly labelled emergency gate release.

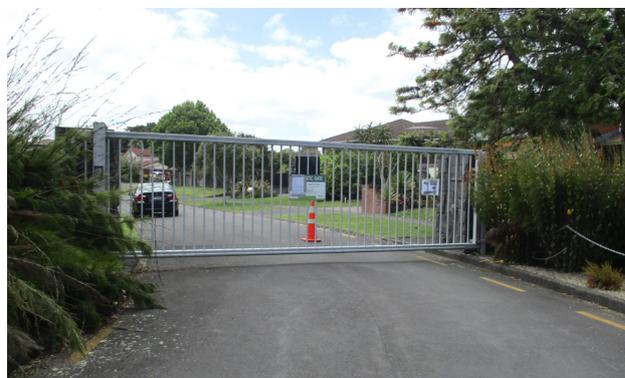
As the car approached, the gate opening activated and the child was pulled into the space between the wall behind the gate and the bars of the gate (the gate housing).

The gate had no safety devices to protect people from injury as it opened. These devices are designed to detect obstructions such as objects and people, stop the gate, and force it to move in the opposite direction so the object or person is released.

FIGURE 2: Child, represented by cone on other side of gate, was playing near gate housing (left in front of wall). As the gate retracted towards the left side, the child was drawn into gate housing

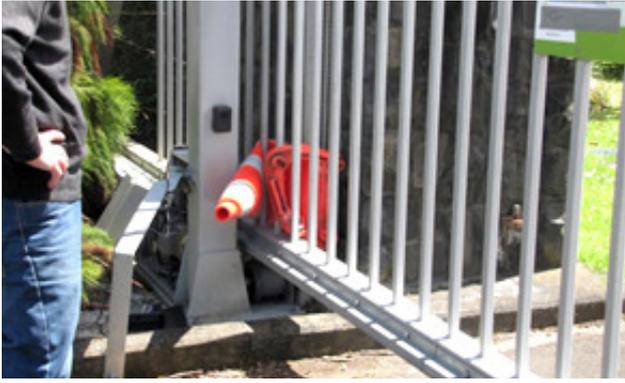
FIGURE 3: The gate, closed, with cone caught in gate housing

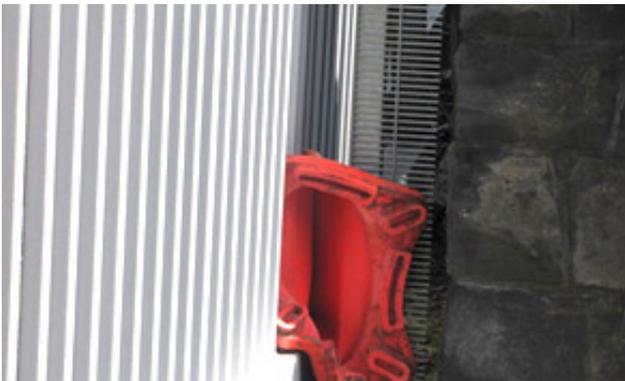
FIGURE 4: The fully closed gate showing cone from the side the child was playing on
